*Shoreline conditions and bank recession
along the U.S. shorelines of the St. Marys,
St. Clair, Detroit and St. Lawrence rivers*

CRREL Report 82-11

Lawrence W. Gatto

SHORELINE CONDITIONS AND BANK RECESSION ALONG THE U.S. SHORELINES OF THE ST. MARYS, ST. CLAIR, DETROIT AND ST. LAWRENCE RIVERS

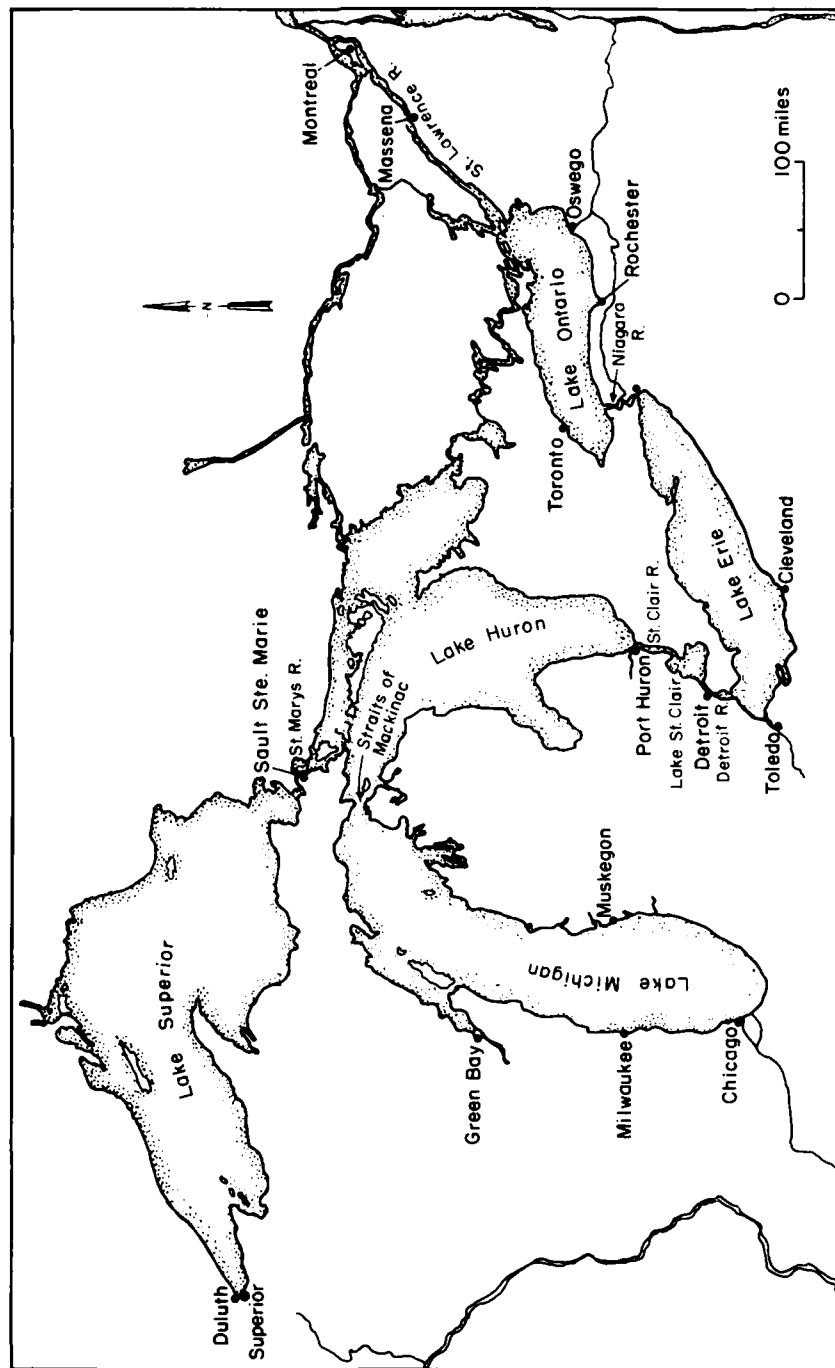
Figure 1. Map of the Great Lakes region.

Previous Corps of Engineers investigations indicated the need for additional studies of the effects of the Great Lakes-St. Lawrence Seaway Navigation Season Extension Program on natural bank erosion processes along the Great Lakes connecting channels, the St. Marys, St. Clair, Detroit and St. Lawrence rivers (Fig. 1). These investigations were limited to specific locations along the shoreline of the St. Marys River. An assessment of the entire shoreline of each river was necessary to evaluate adequately the potential impacts of winter navigation on bank erosion.

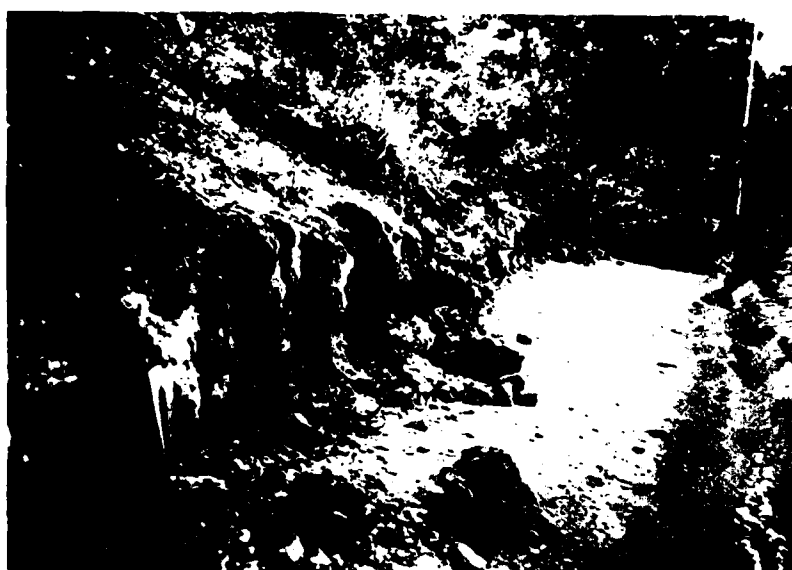
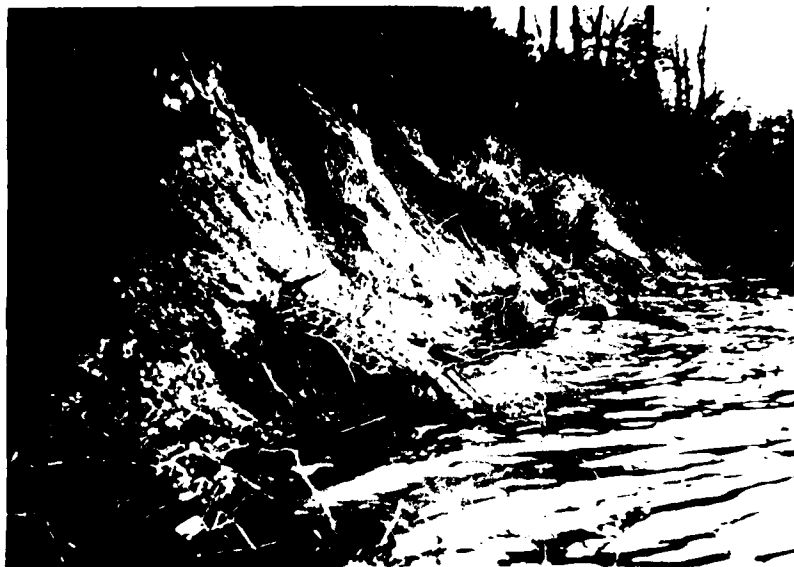
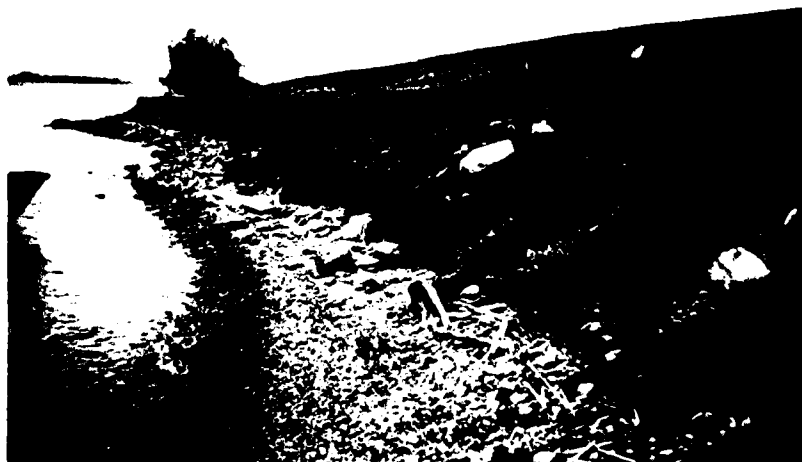
Figure 7. Most common types of bank failures.

a. Soil fall (St. Marys River reach 27b).

b. Soil fall (St. Clair River reach 5a).

c. Soil fall (Detroit River reach 18).

d. Soil slide (St. Lawrence River reach 26).

The types of bank failure along most of the eroding reaches were soil falls and slides (Fig. 7) (Code 1973). Soil falls generally result from extreme undercutting at the toe of a bank, and they usually produce vertical bank faces. Slides are due to shear failures, which result in relatively undeformed masses of soil moving along a single slide plane. These are common, especially where banks are composed of massive lake sediments or fine-grained tills. The slides along the St. Marys River are also due to the loss of support at the bank toe resulting from undercutting and material removal by river water. A few reaches show rotational slumping, and some show evidence of surface erosion (i.e. rills and gullies).

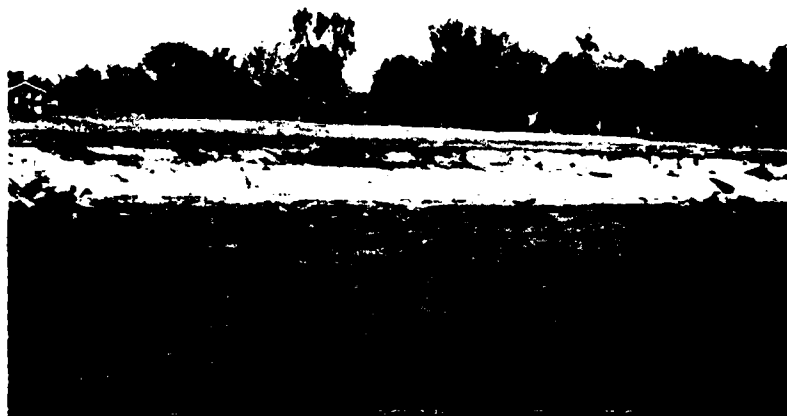
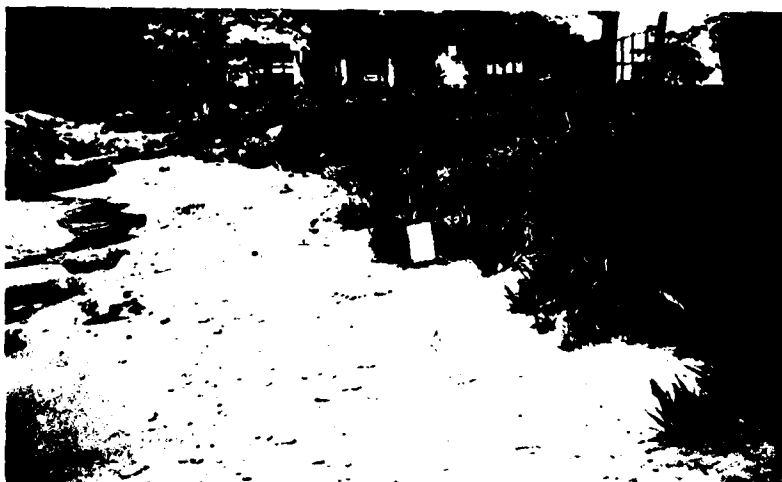
Figure 13. Slumped vegetation covering the low bank face.

a. Detroit River reach 1a.

b. Detroit River reach 2a.

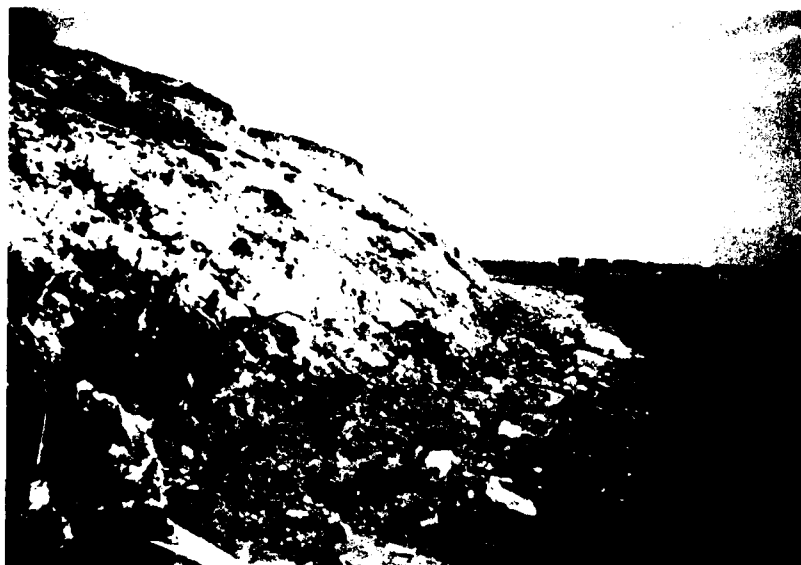
Figure 16. Localized slumps and mudflows along St. Lawrence River reach 35c.

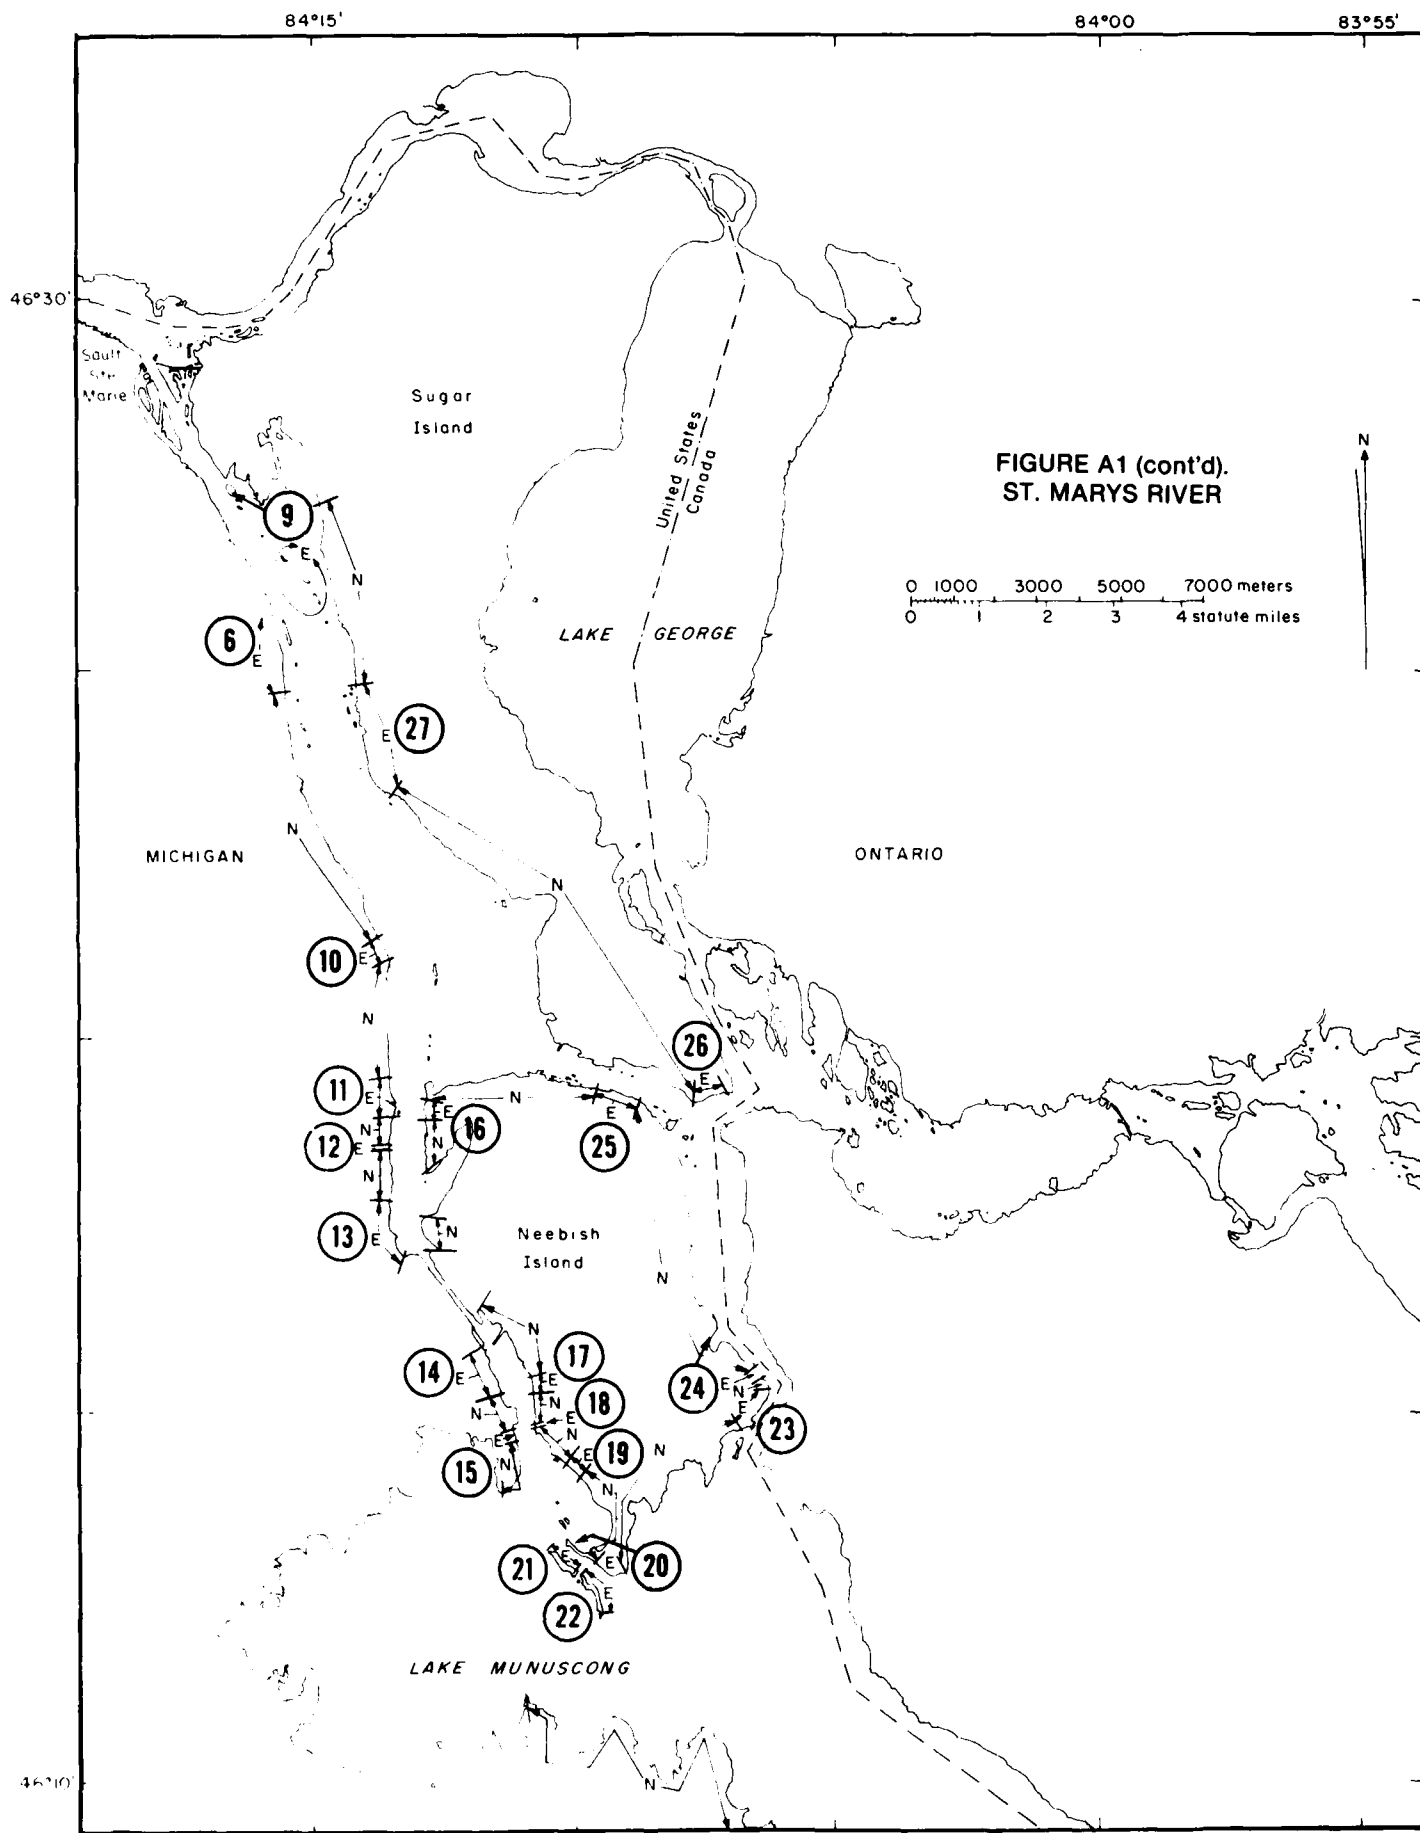
FIGURE A1 (Cont'd).
ST. MARYS RIVER

The maps show the shoreline conditions and bank characteristics as observed on 25, 26 May 1977

The initial boat survey of the St. Marys River (Fig. 6) was made on 25 and 26 May 1977. The shoreline characteristics and conditions observed are shown in Figures A1-A6. Twenty-eight sites, with 66 partially vegetated or bare banks covering a total of 10.7 miles (Table A1, Fig. A1), were delineated during this survey. The banks at 29 of these reaches (5.2 miles) showed evidence of erosion from May 1977 to May 1980. This is 4.3% of the 122 miles of shoreline surveyed. The banks at 37 reaches (5.5 miles) showed no apparent changes.

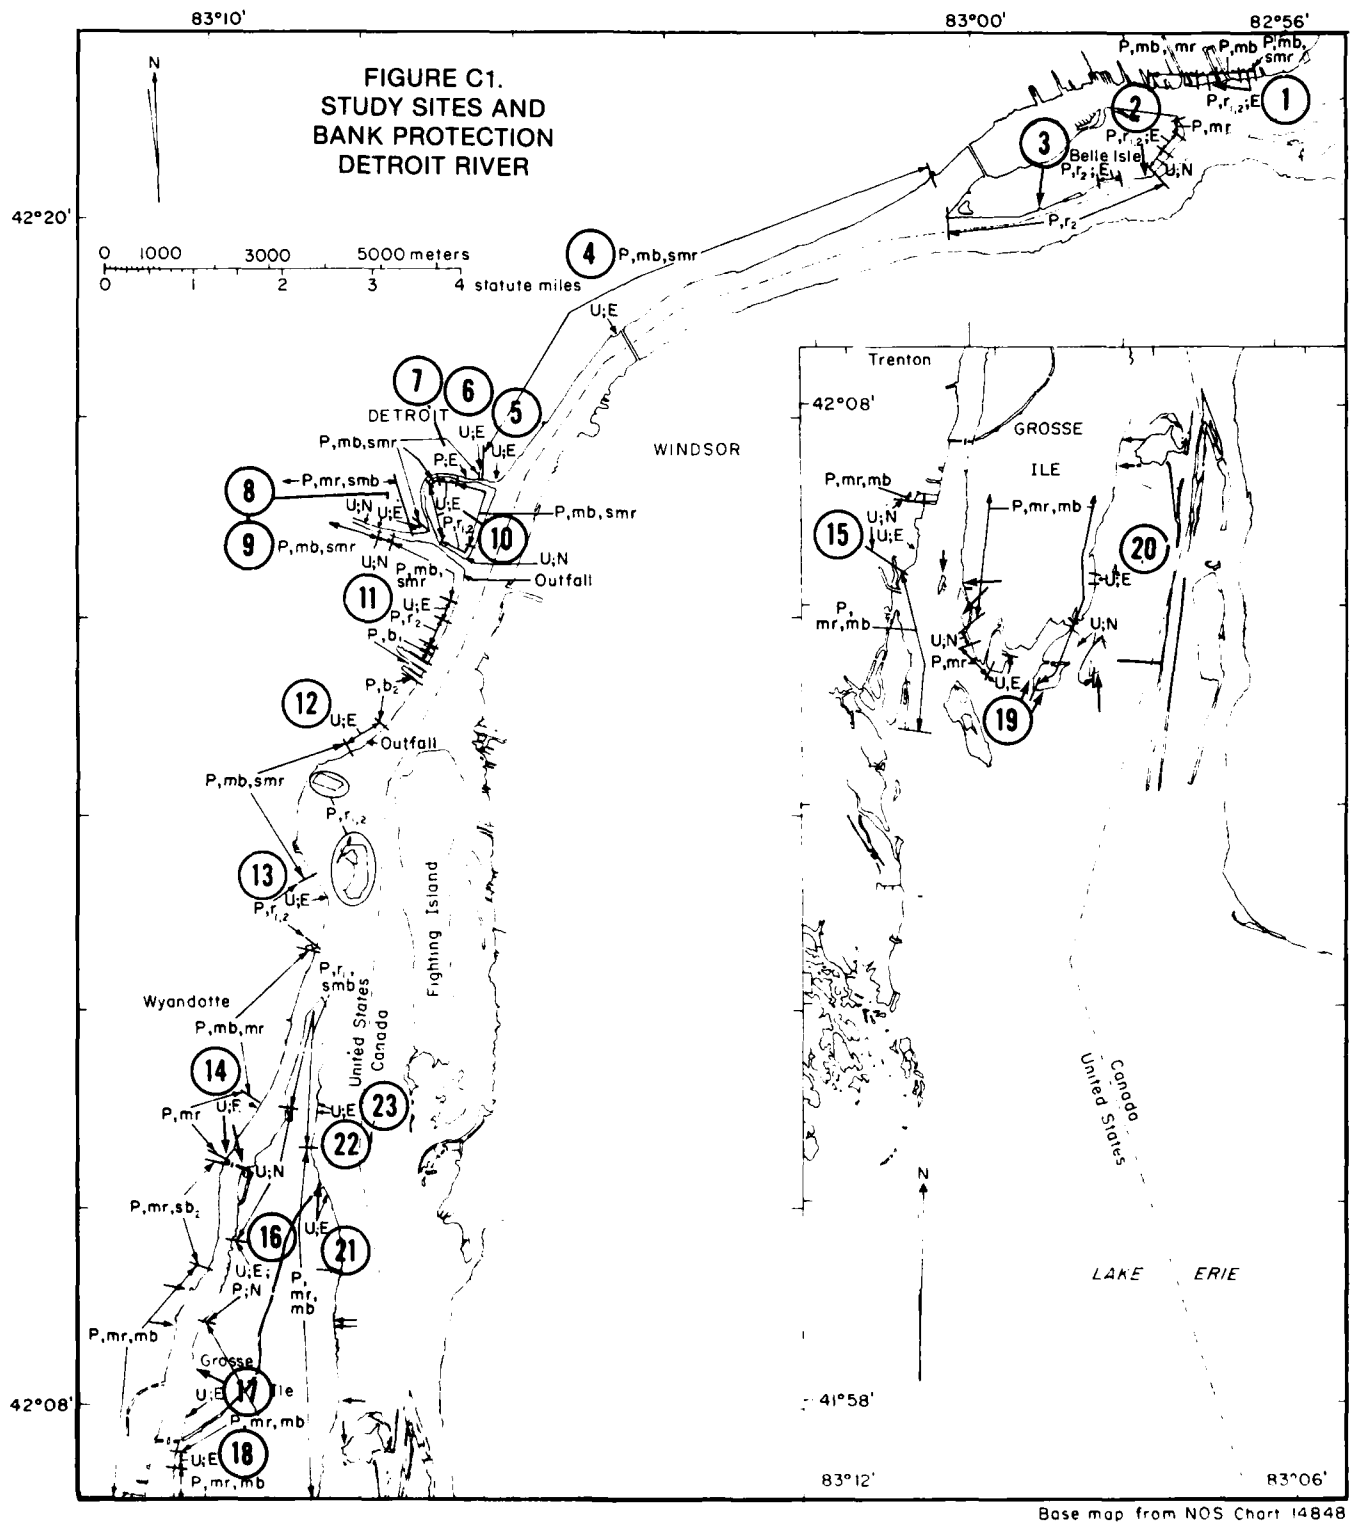
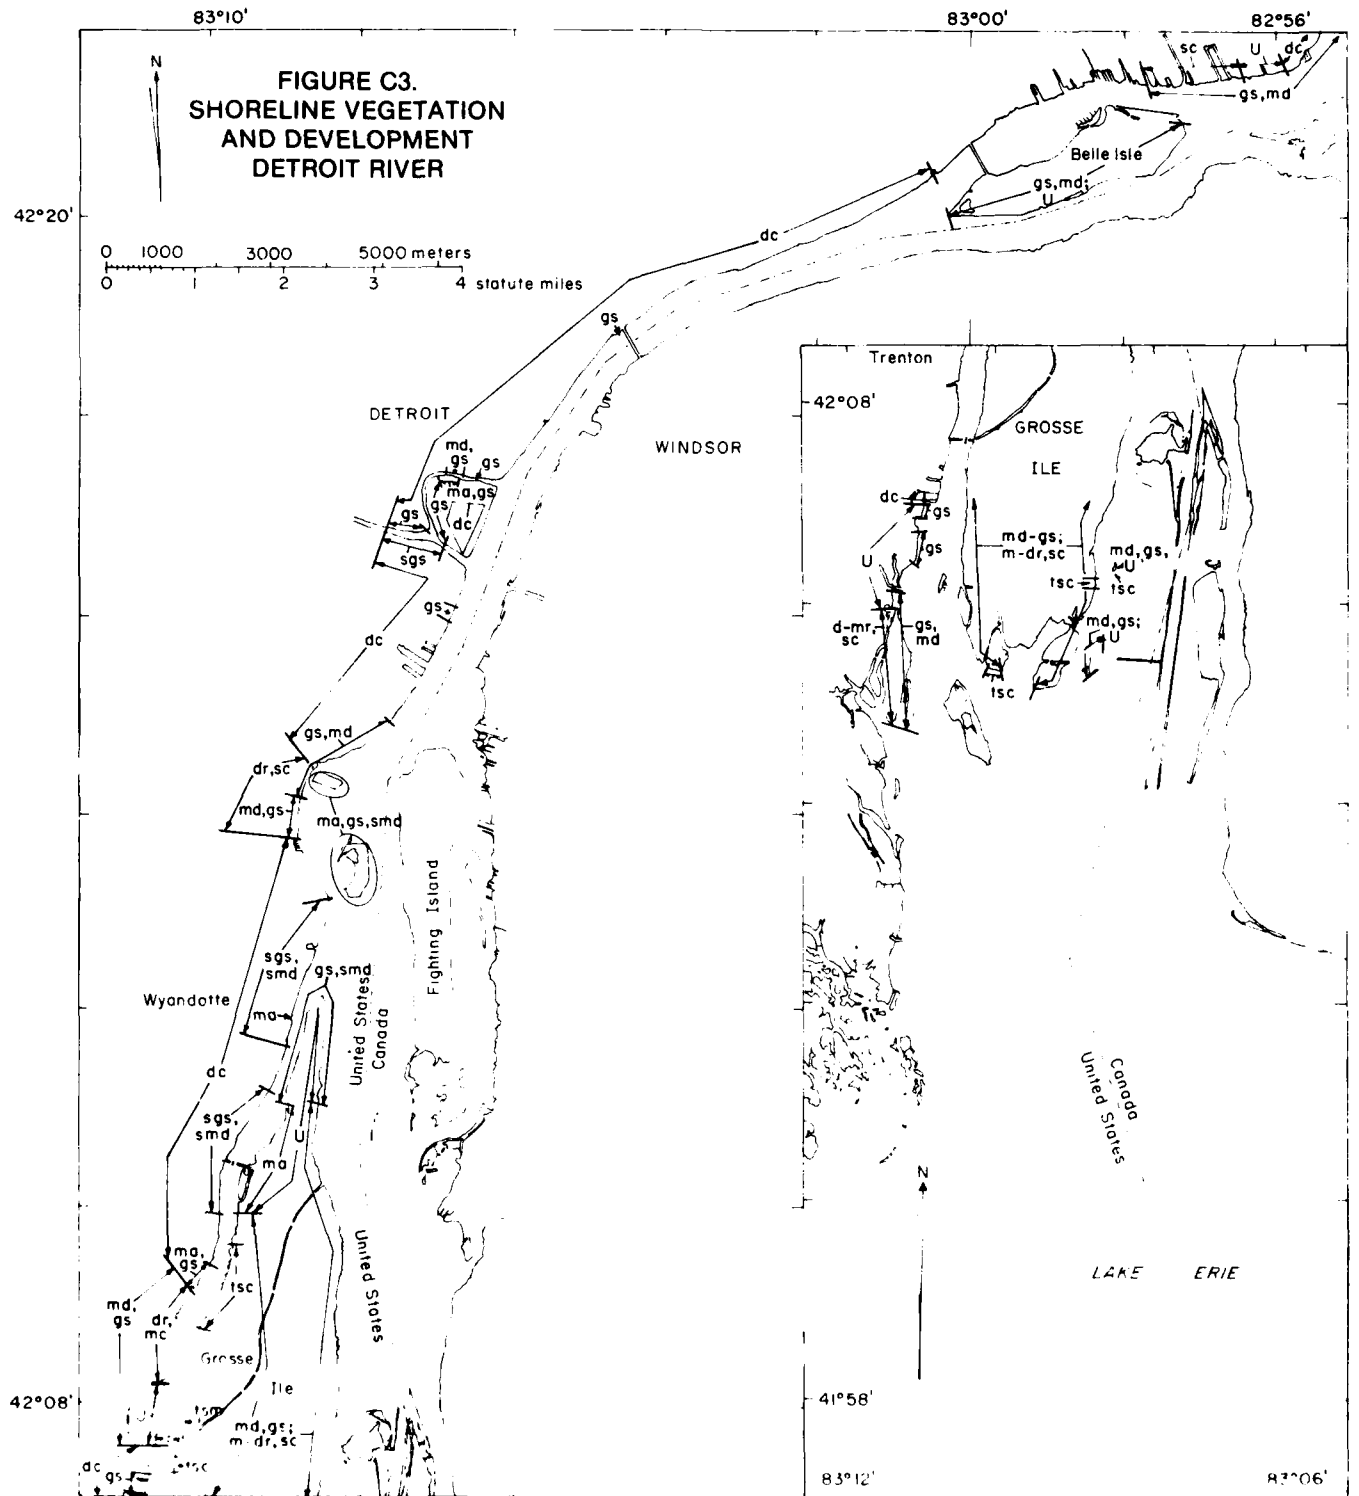
APPENDIX C: DETROIT RIVER. The maps show the shoreline conditions and bank characteristics as observed on 23, 24 May 1977. Refer to the legend in Appendix A for explanations of map symbols.

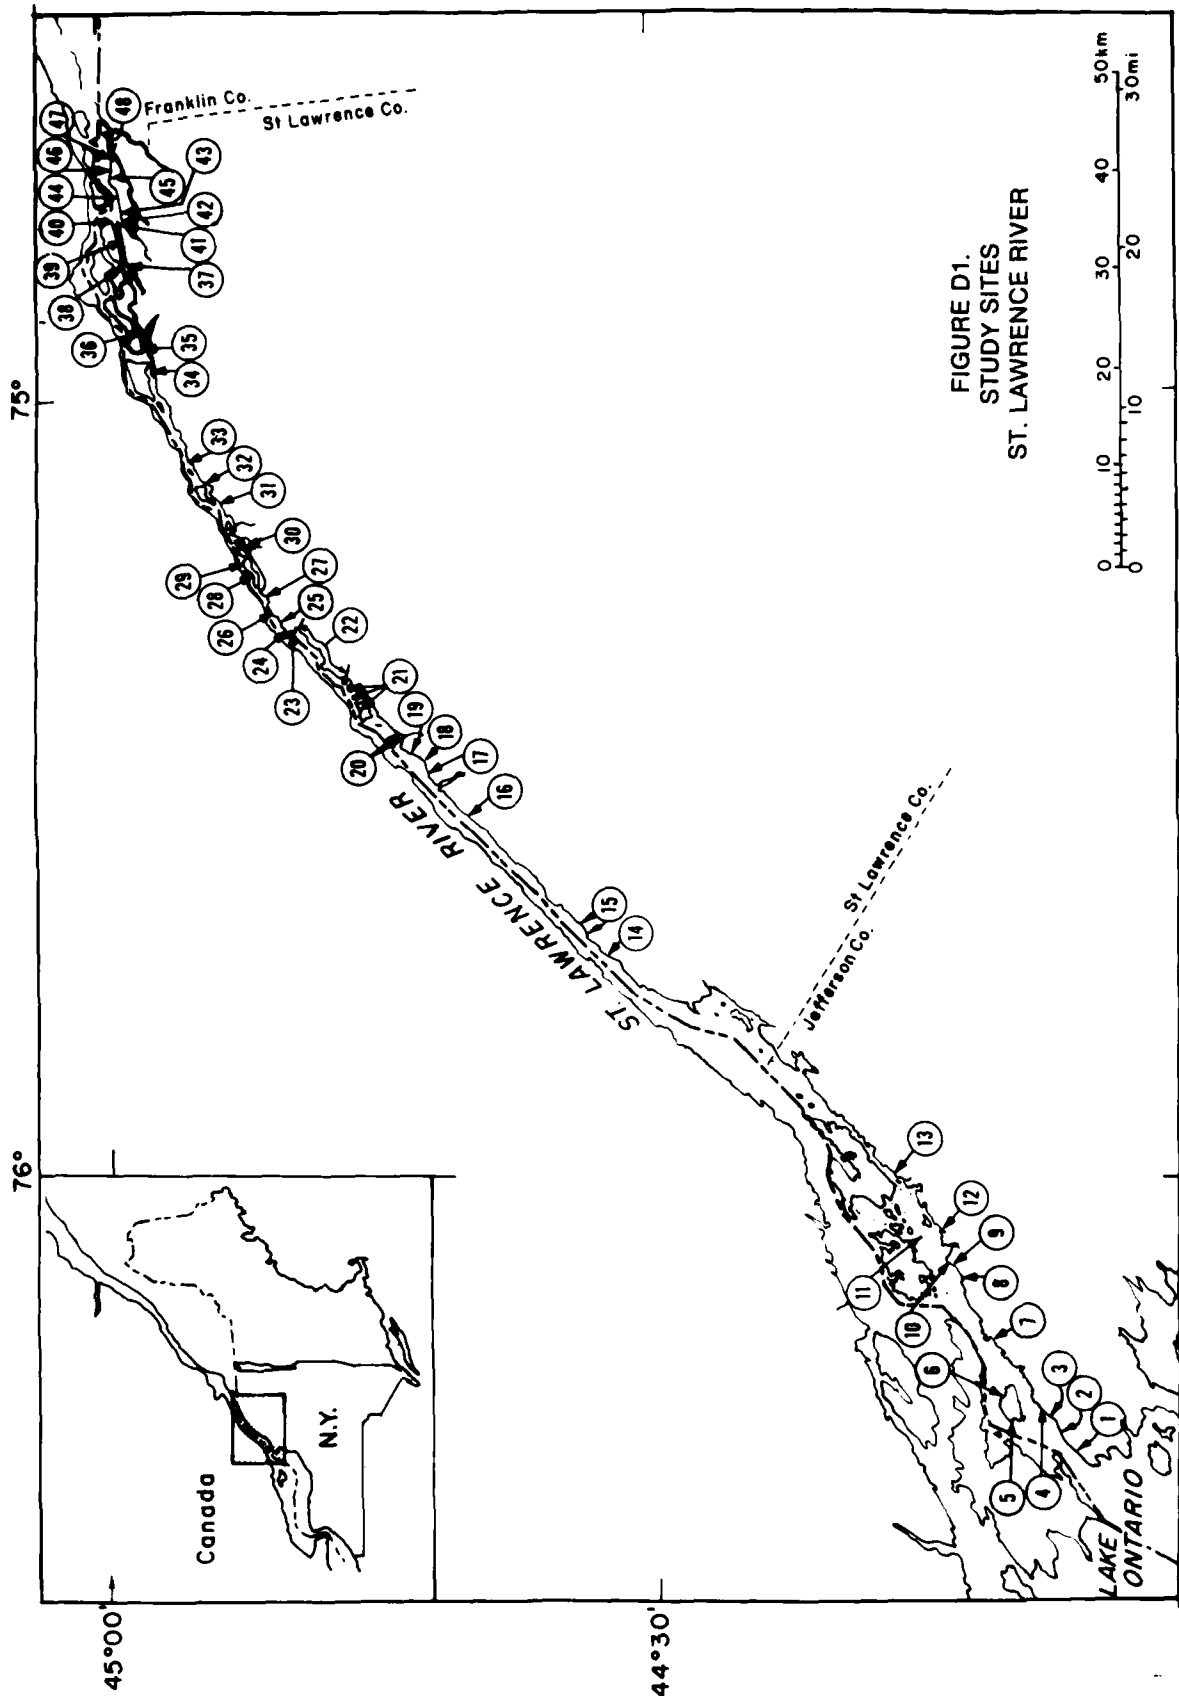
FIGURE D1.
STUDY SITES
ST. LAWRENCE RIVER

APPENDIX D: ST. LAWRENCE RIVER. The maps of bank characteristics, beach sediment, shoreline vegetation, bank protection and shoreline development were not prepared since much of this information is already available in the St. Lawrence-Eastern Ontario Commission (1977a) report.

The initial boat survey of the St. Lawrence River from Lake Ontario to the U.S.-Canadian border near Massena, New York (Fig. 15), was made on 16 and 17 November 1977. I delineated partially vegetated or bare banks at 114 reaches (covering 10.9 miles) at 48 sites (Table D1, Fig. D1). During this project, erosion occurred along 8.6 miles of the riverbank at 59 reaches. This is 6.6% of the 130 miles of surveyed shoreline. Fifty-five reaches, about 2.3 miles of bank, appeared to be stable from 1977 to 1979. Erosion along some of these banks would probably begin if water levels were raised for an extended period.
